TEST REPORT

No. : XMCCM160400465

Sample Name : FLOOR GRAPHIC
SGS Ref. No. : CP16-020392
Test Required : Selected test(s) as requested by applicant
Date of Receipt : Apr.15, 2016
Test Period : Apr.15, 2016 to Apr.21, 2016

Slip resistance (oil-wet ramp test)

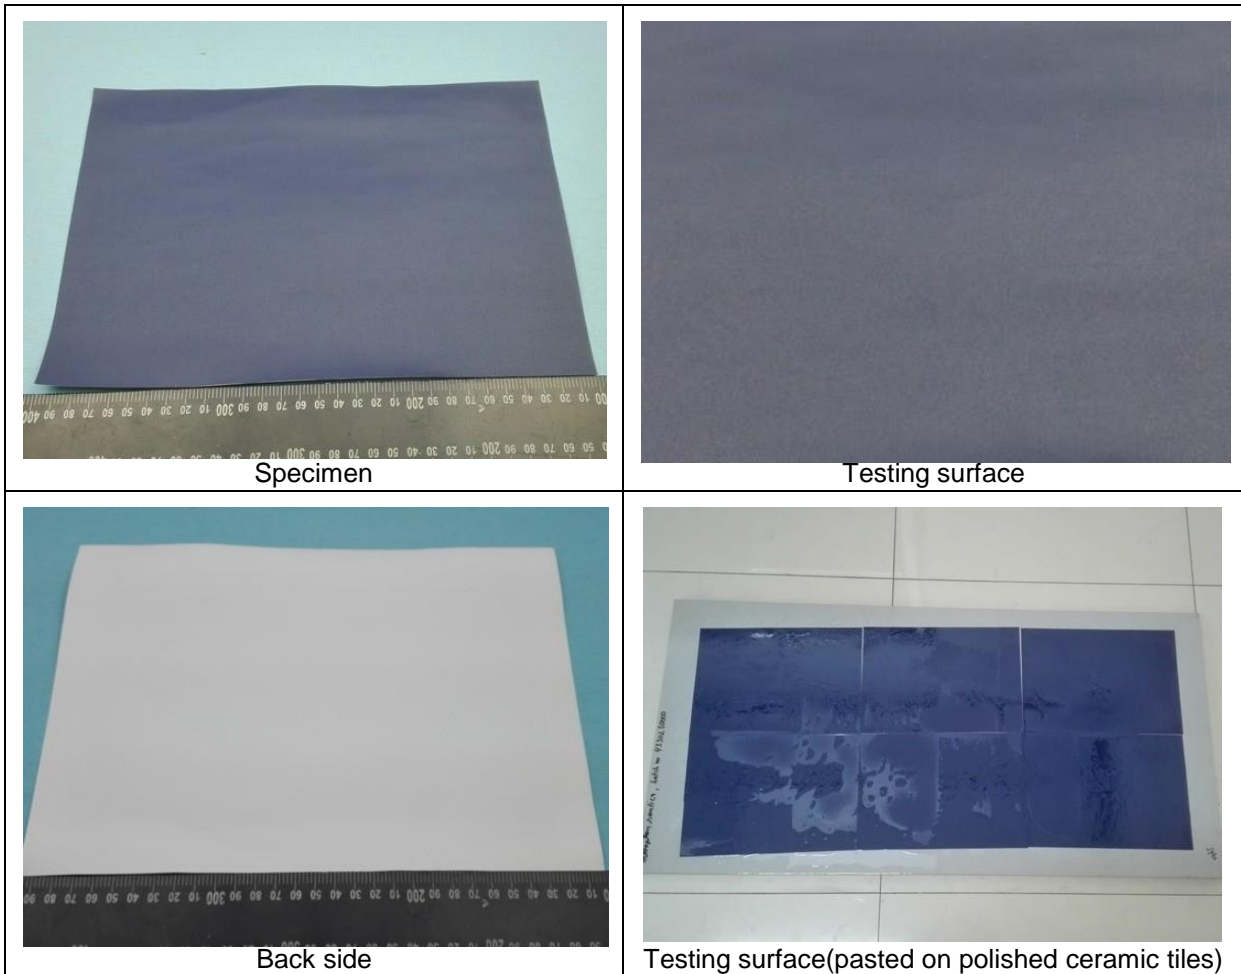
Specimen photographs:

Film, 6 pcs of specimens 295mmx210mm were pasted on polished ceramic tiles to form a testing surface 885mmx420mm

Testing surface: see the photos

| Test item(s) | Test result(s) | Classification |
|---|---|---|
| Slip resistance (oil-wet ramp test) | Critical angle of inclination: 10.4° | R10 |
